UNDERWATER SURVEY REPORT

M/V. SHUN YING 8

Scope of work: Inspect underwater Overboard covering for M/V SHUN YING 8

Operation Date: 6 th April 2022

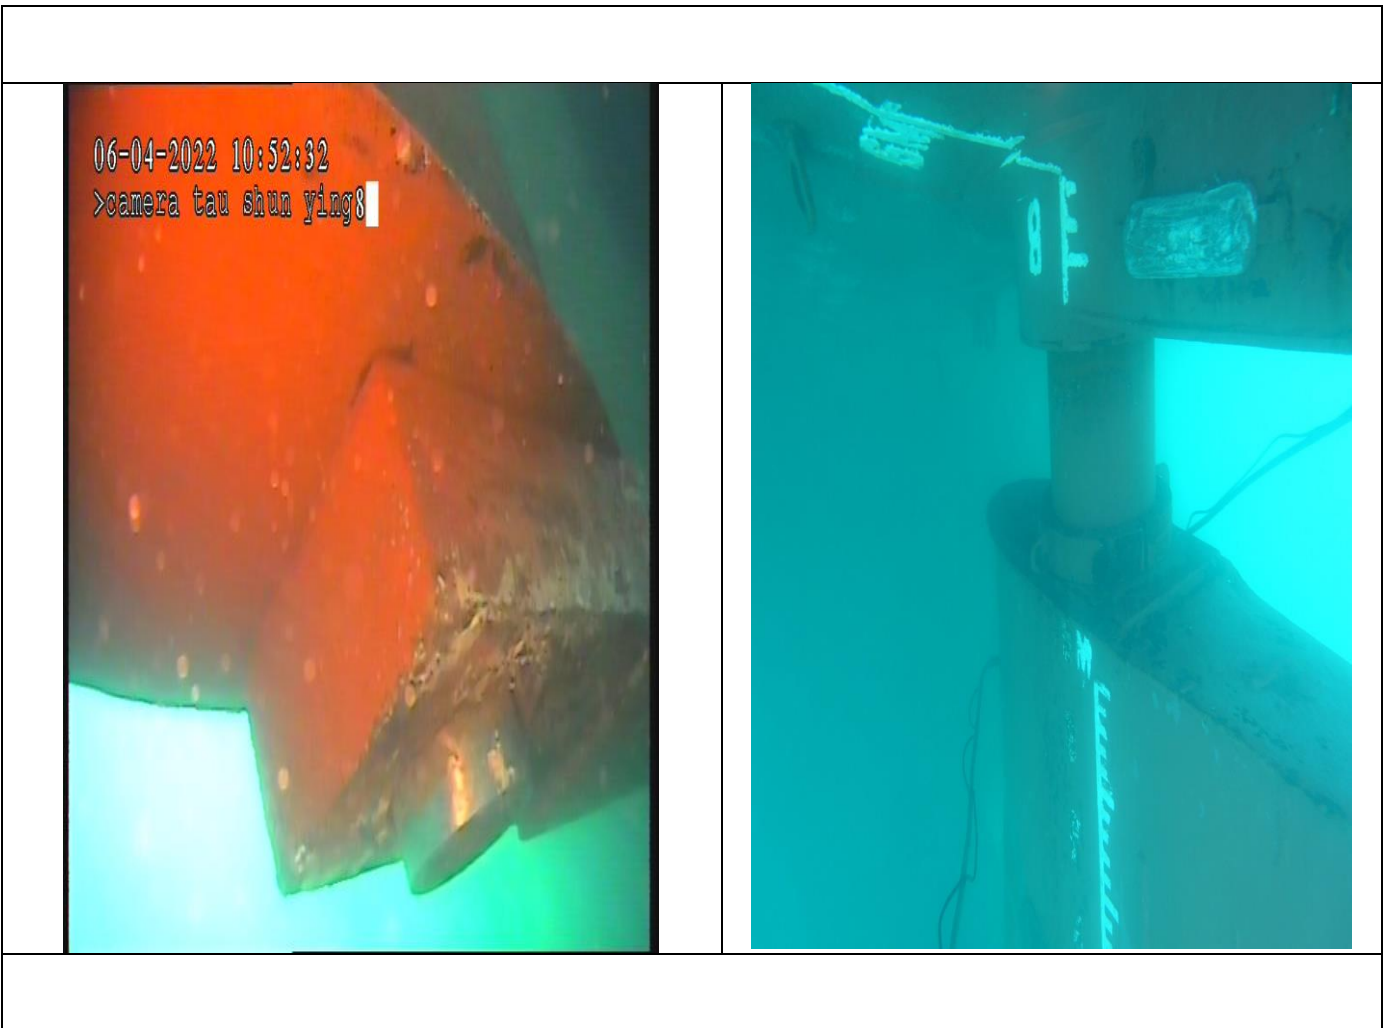
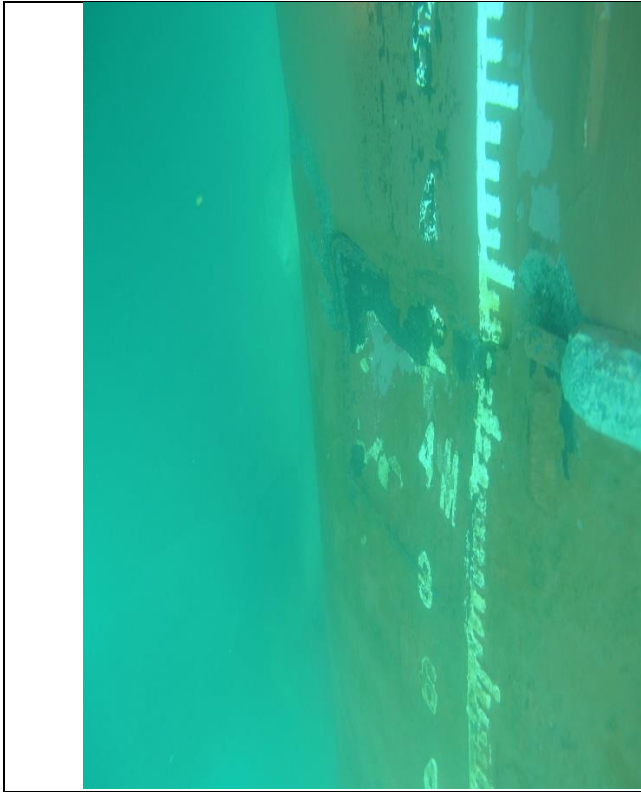
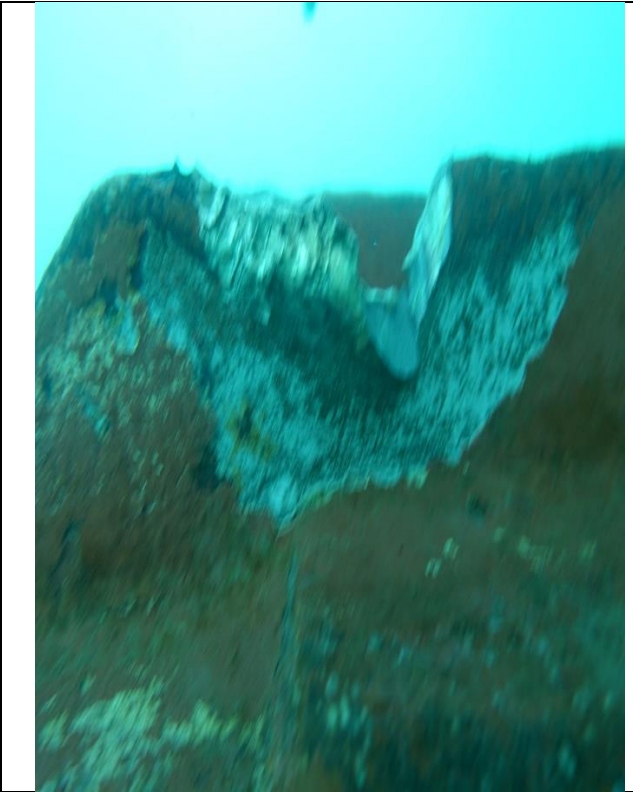
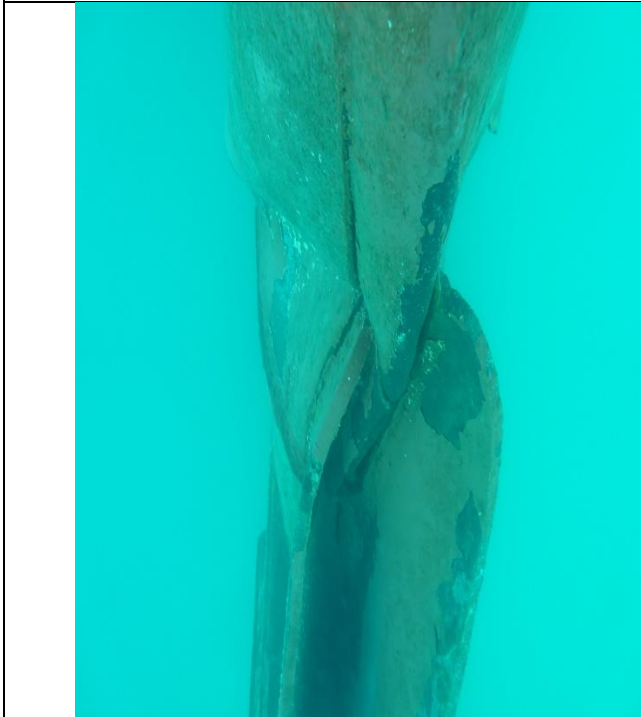
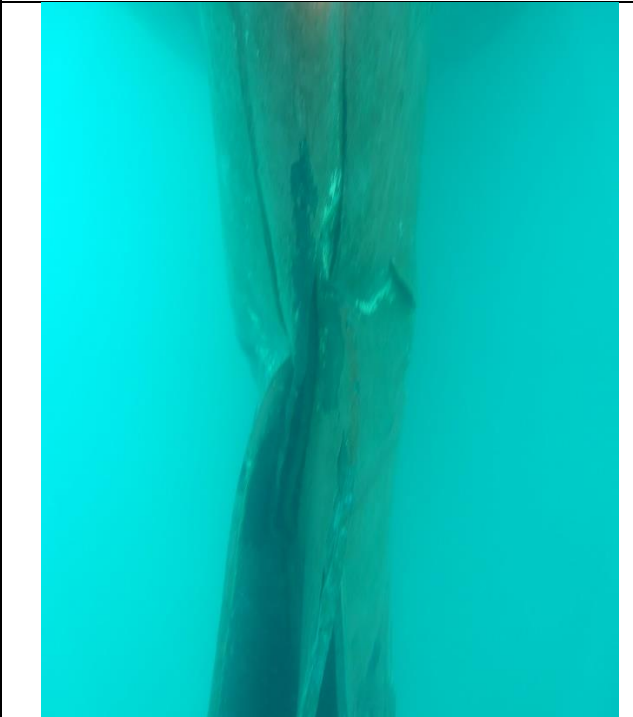
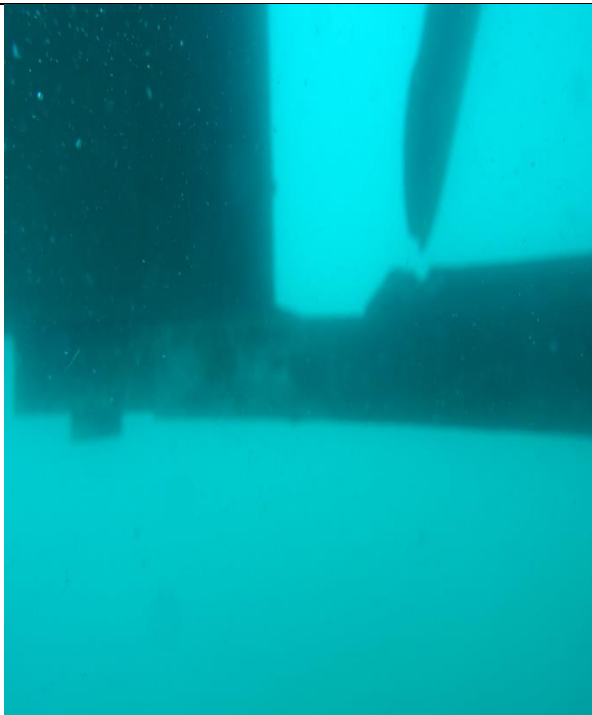
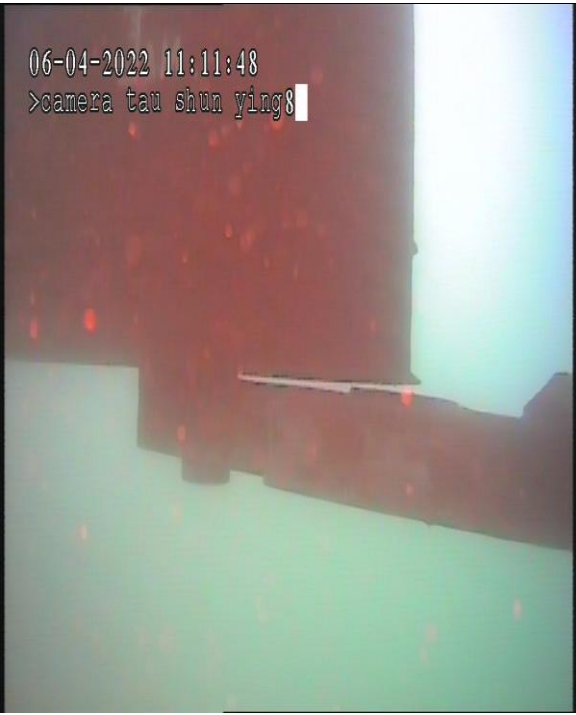
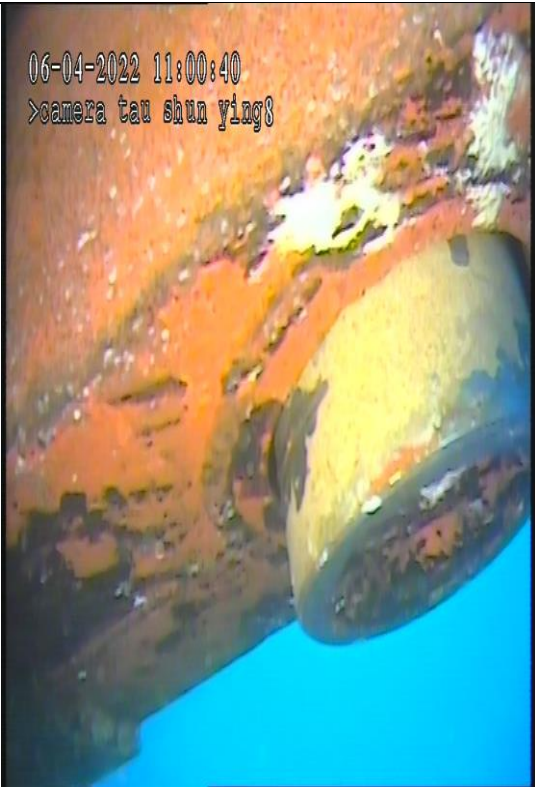
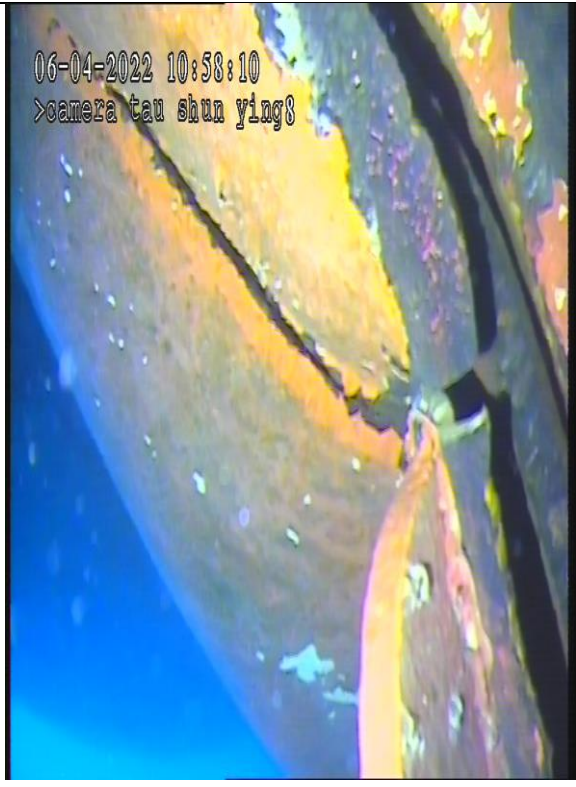
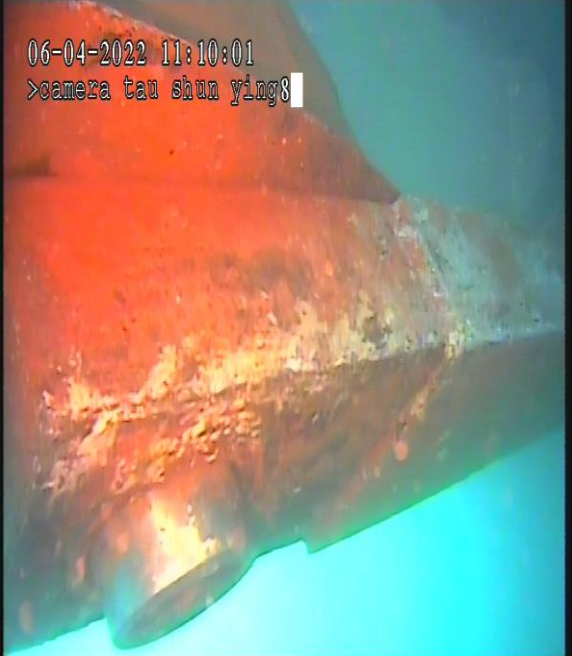
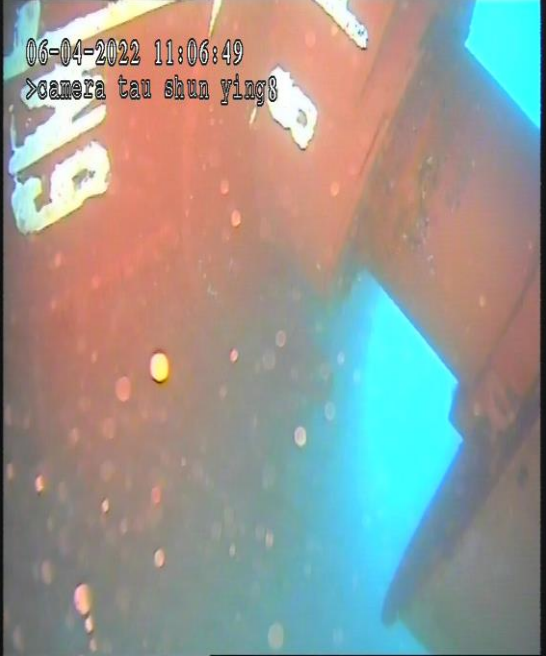
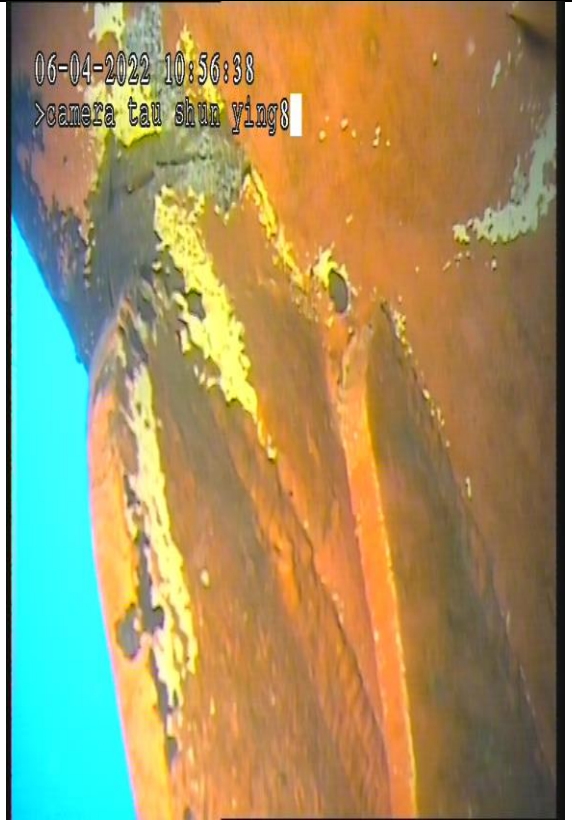
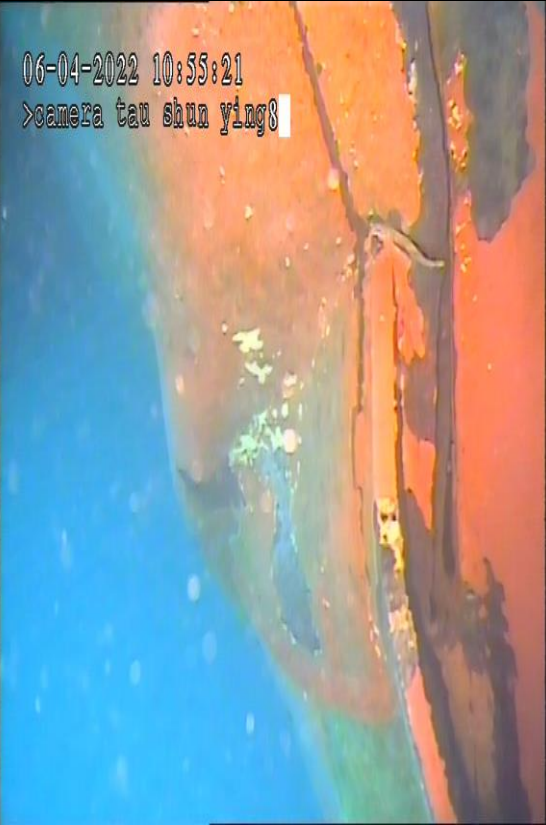
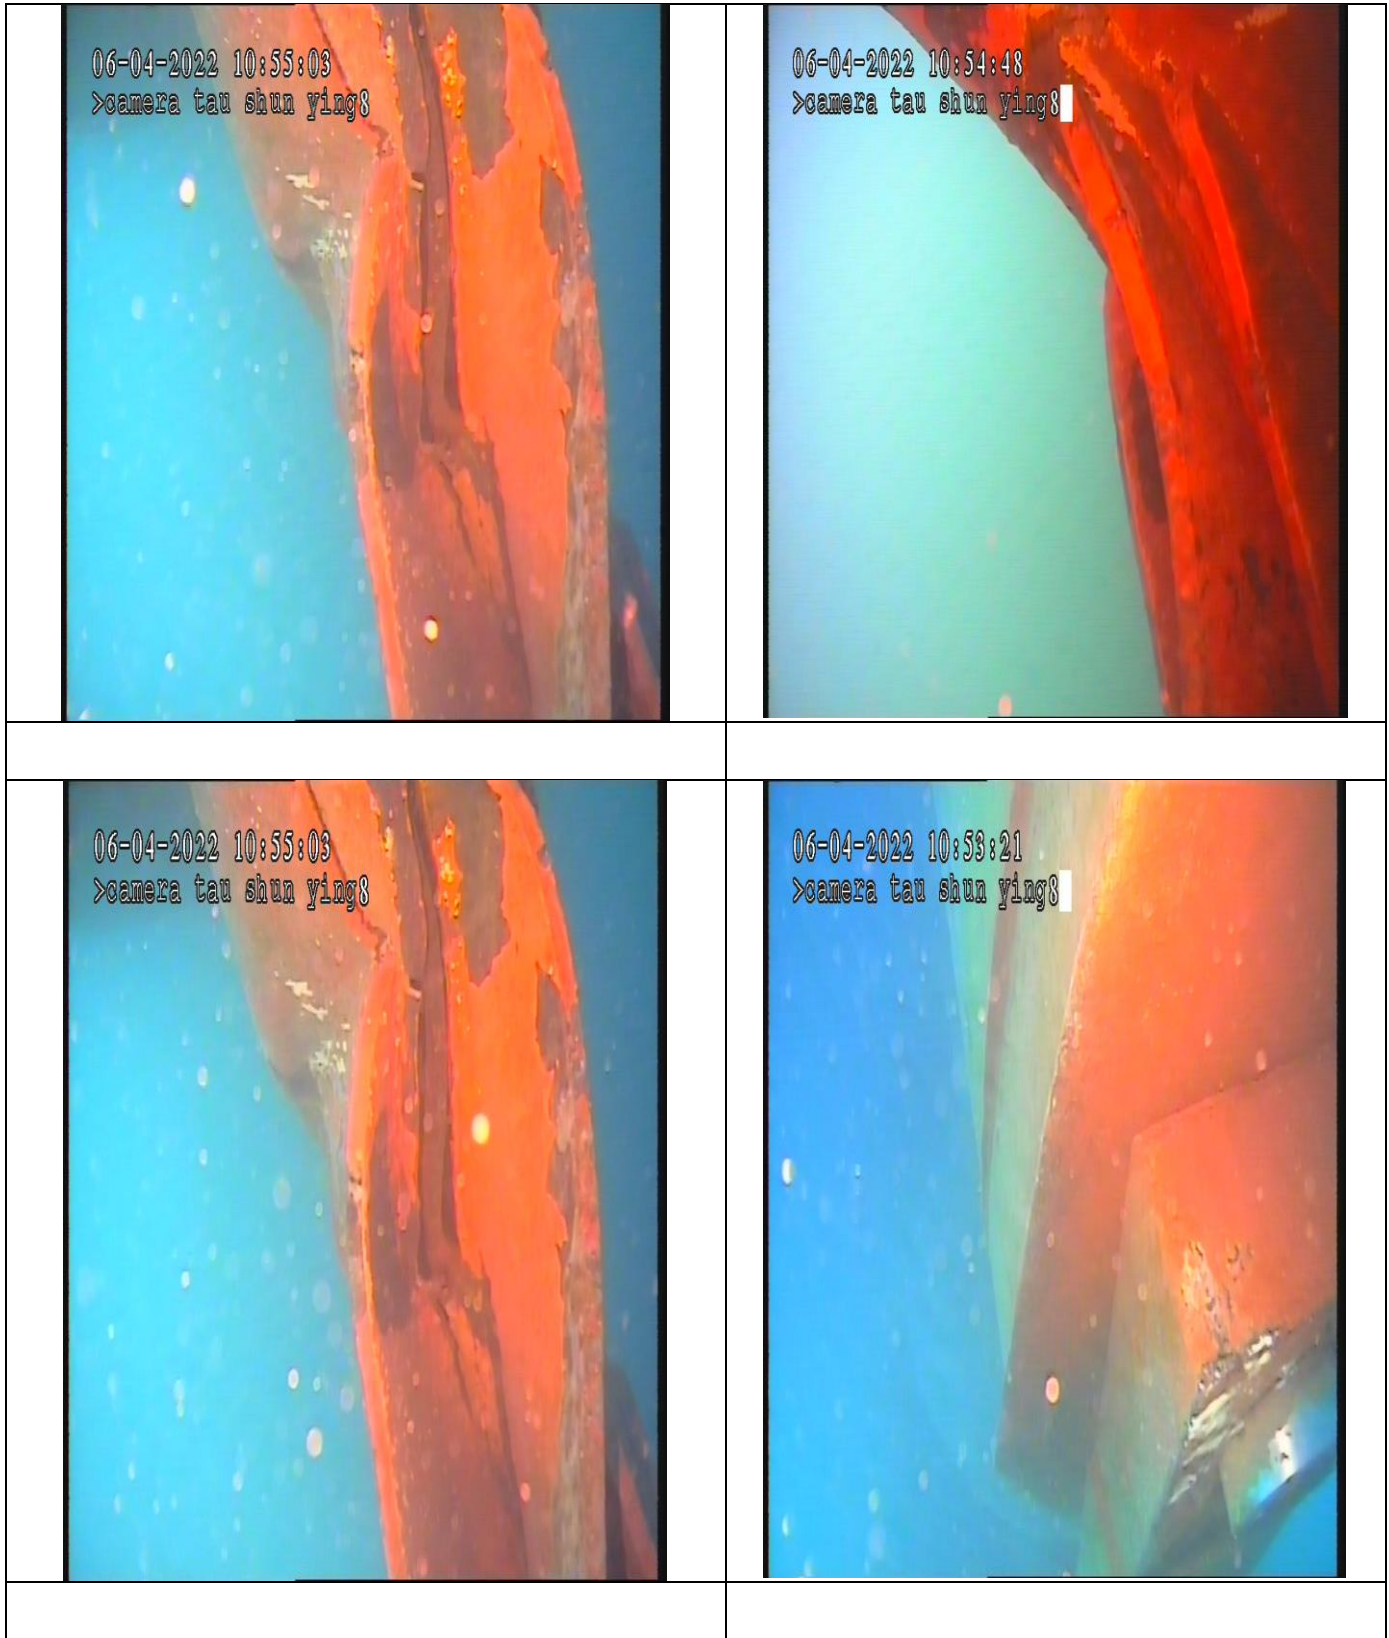
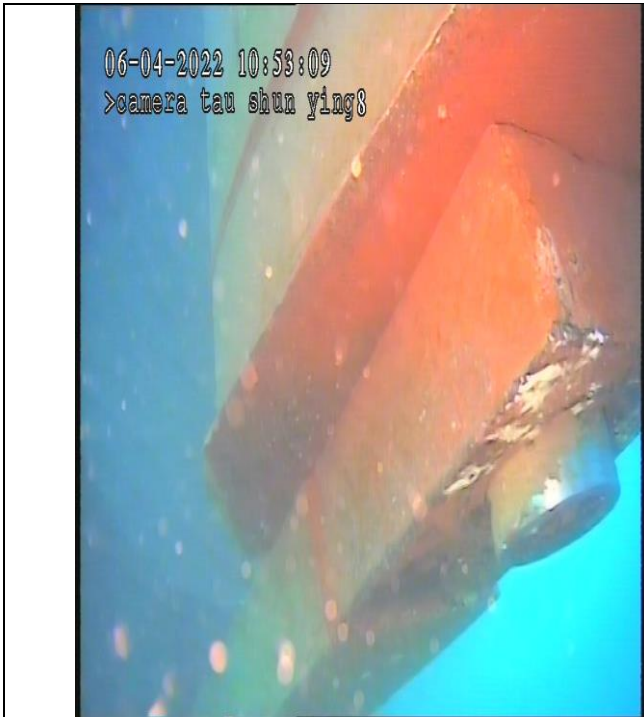
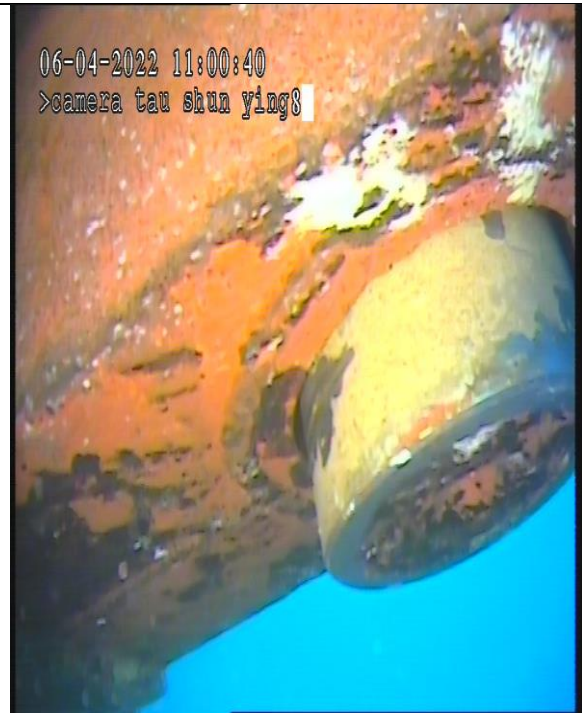
RUDDER CONDITION

- Rudder leading Visible damage
- Rudder Stock Visible damage
- Plate condition of Rudder severely deformed mechanically
- Displaced rudder shaft is not in original position

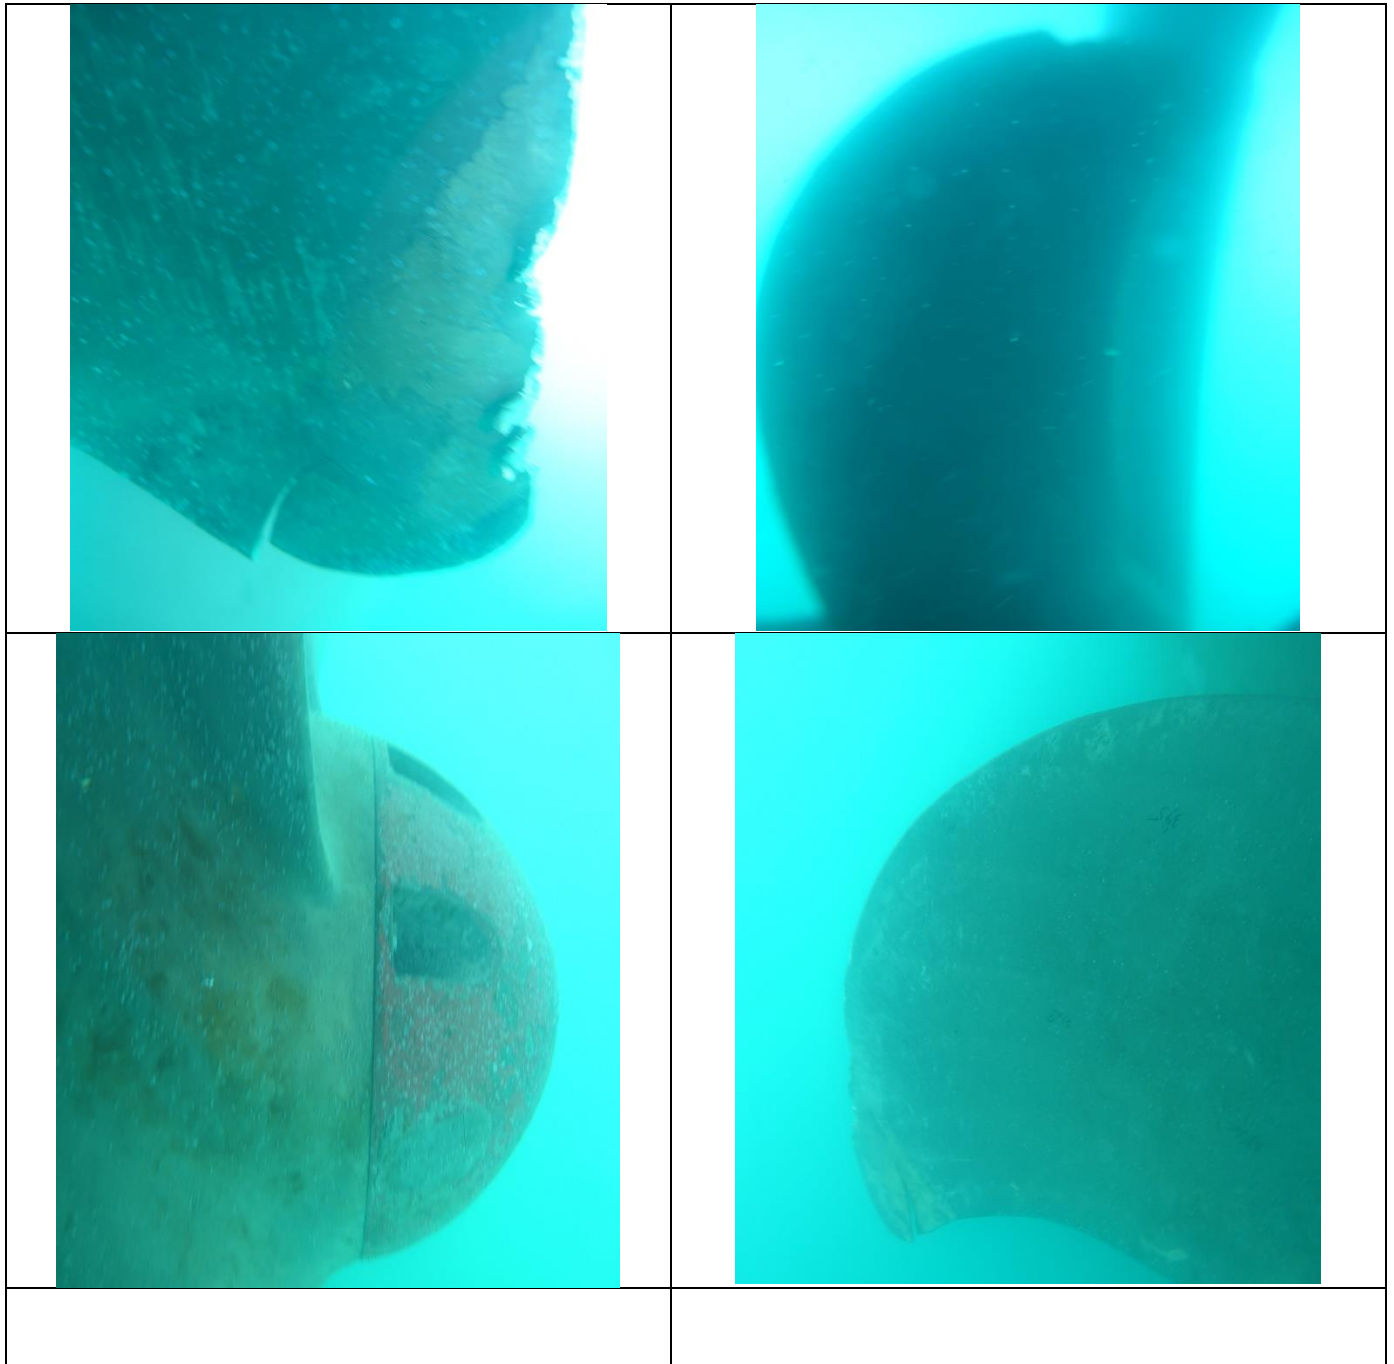
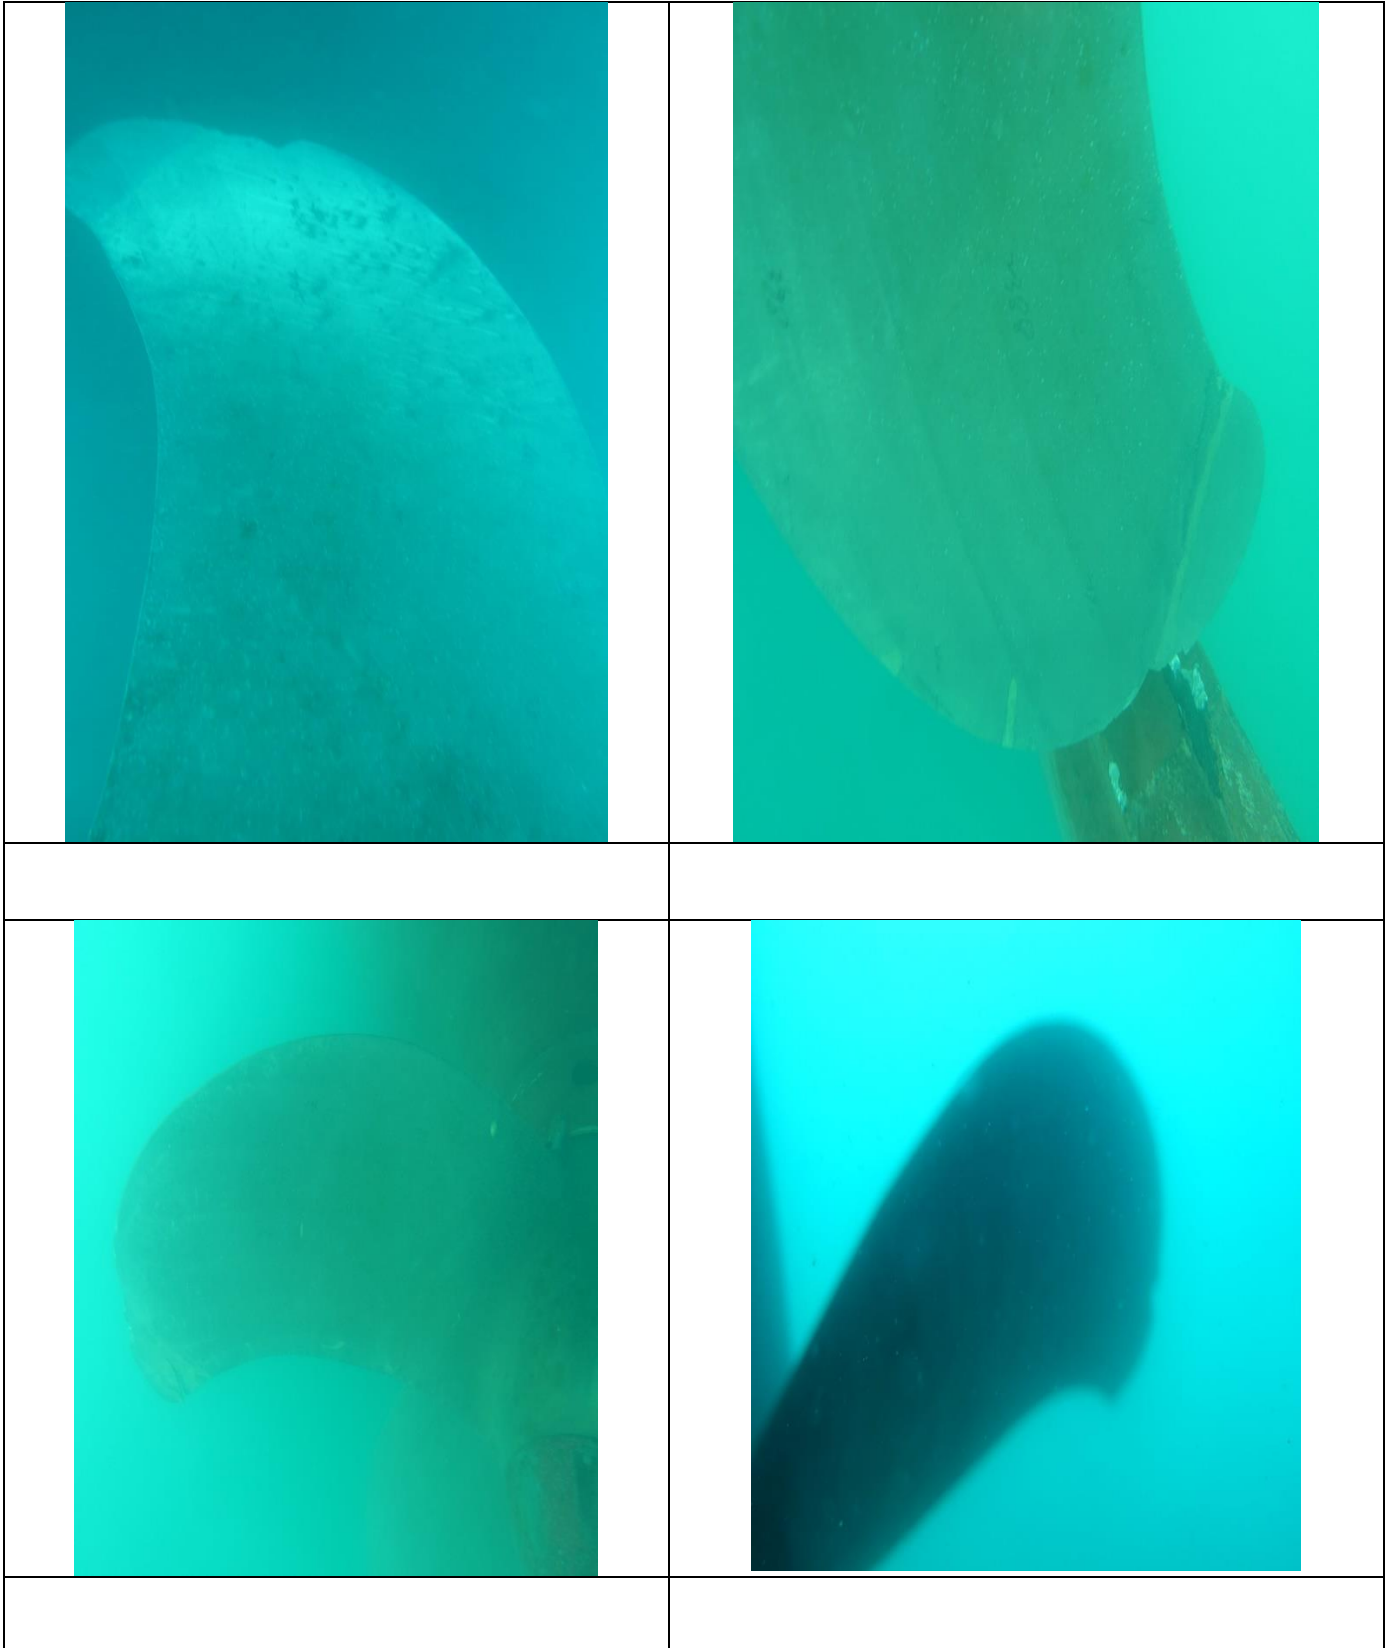
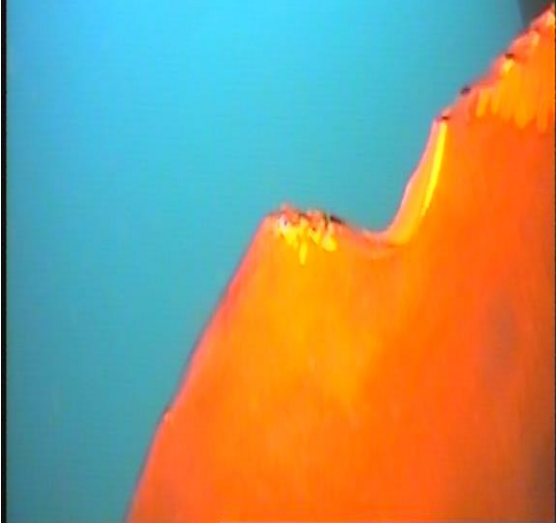
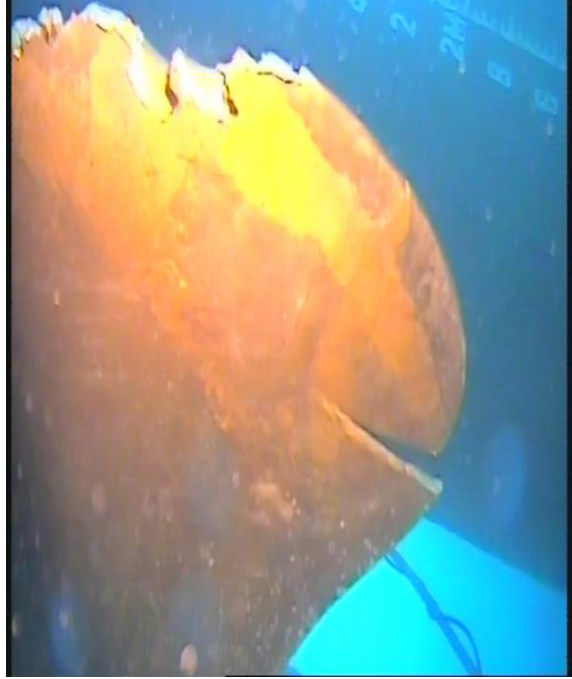
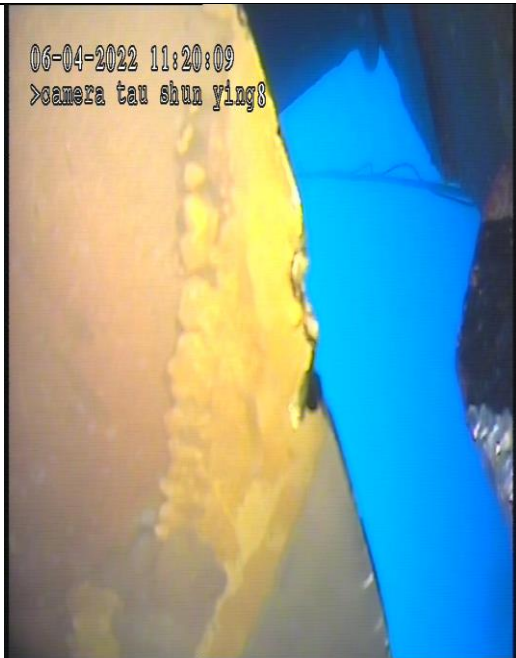
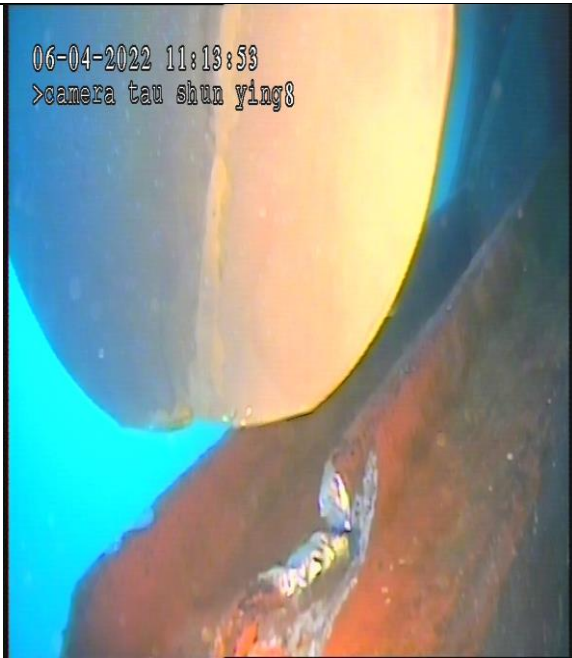
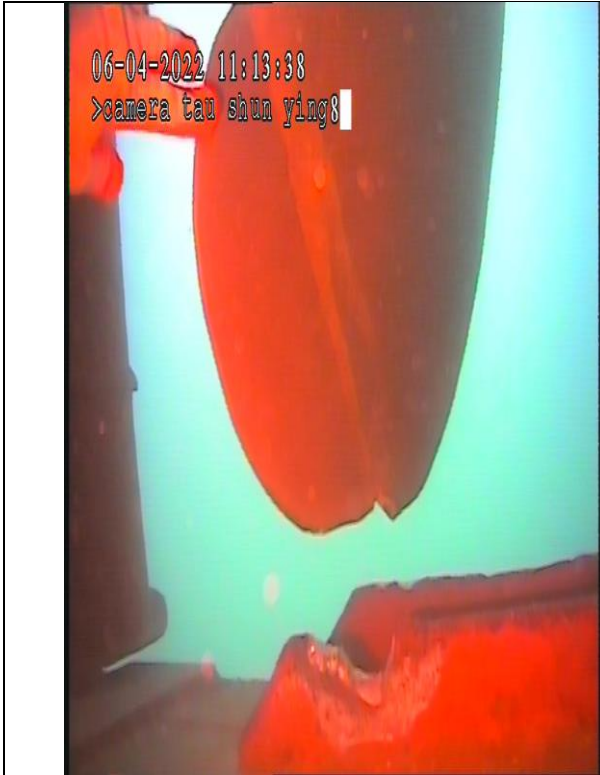
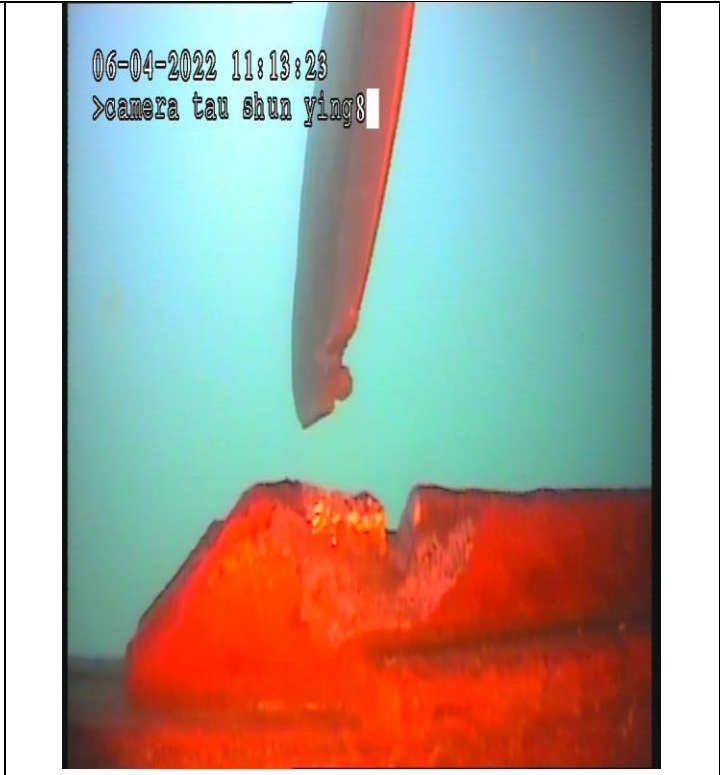
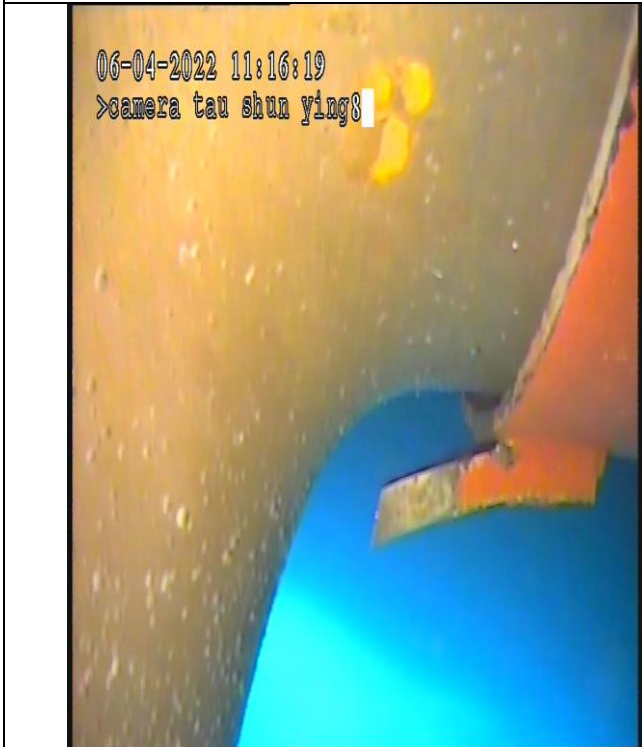
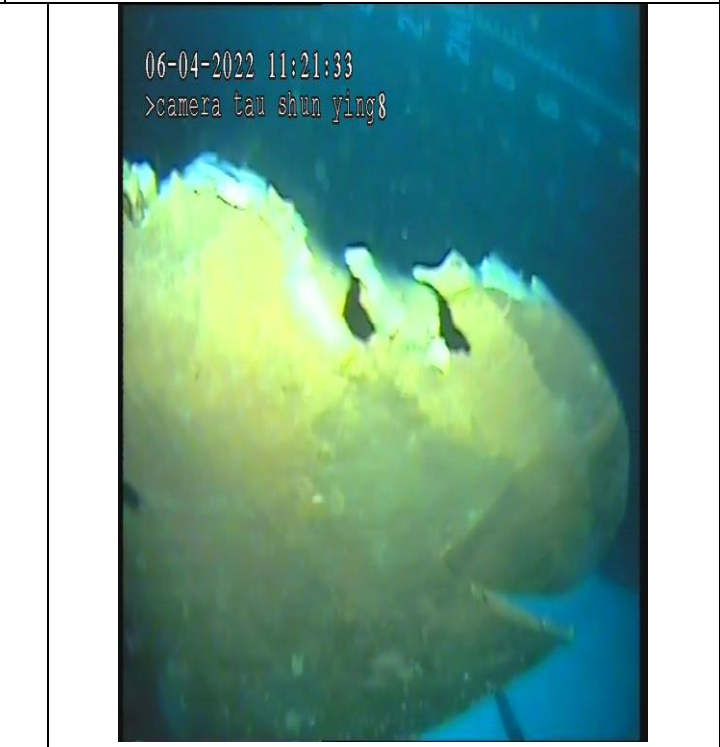
PROPELLER CONDITION

- we can see damage to the propeller's 4 blades
- All four propeller blades are deformed
